UNC
ENVIRONMENTAL
HEALTH & SAFETY

September 6, 2013

Subject: The University of North Carolina at Chapel Hill (UNC-Chapel Hill) Bingham Facility

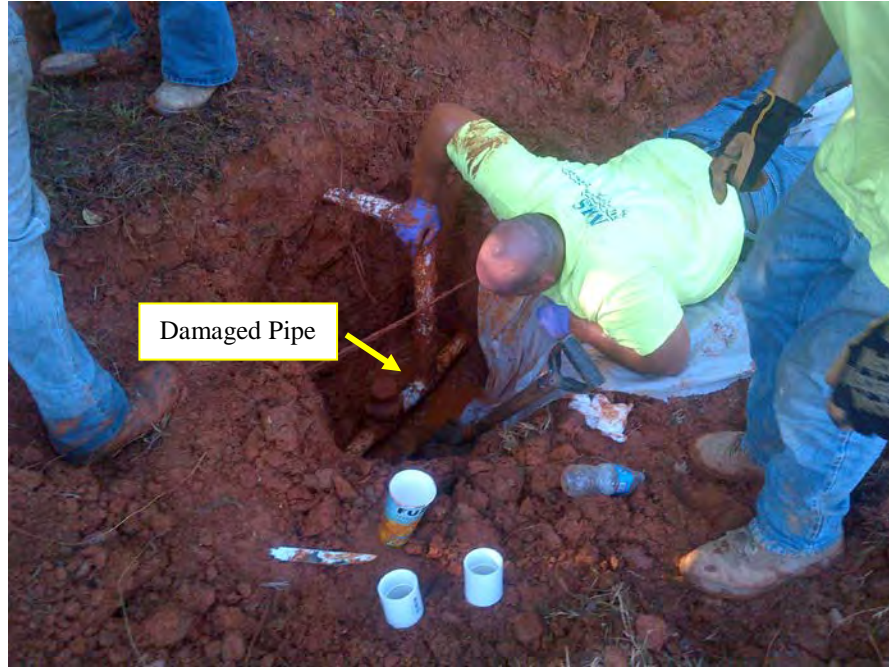
At around 3:45 pm on September 3, 2013, the Operator in Responsible Charge (ORC) identified a piping leak at the subject facility. The buried piping is a 2-inch diameter effluent force main located between the small effluent basin and the AdvanTex wastewater system. The piping was damaged by construction equipment working in the area (see Picture 1).

It is estimated that approximately 15 gallons of wastewater were released into soils surrounding the leaking pipe. The wastewater was removed from the excavation by Mid-Atlantic Infrastructure Systems, Inc. (MIS) and transported to the nearby Equalization Basin. The wastewater discharge did not reach surface waters. Saturated soil from around the piping was excavated by MIS and containerized for off-site disposal.

Picture 1 – Damaged 2-inch force main.

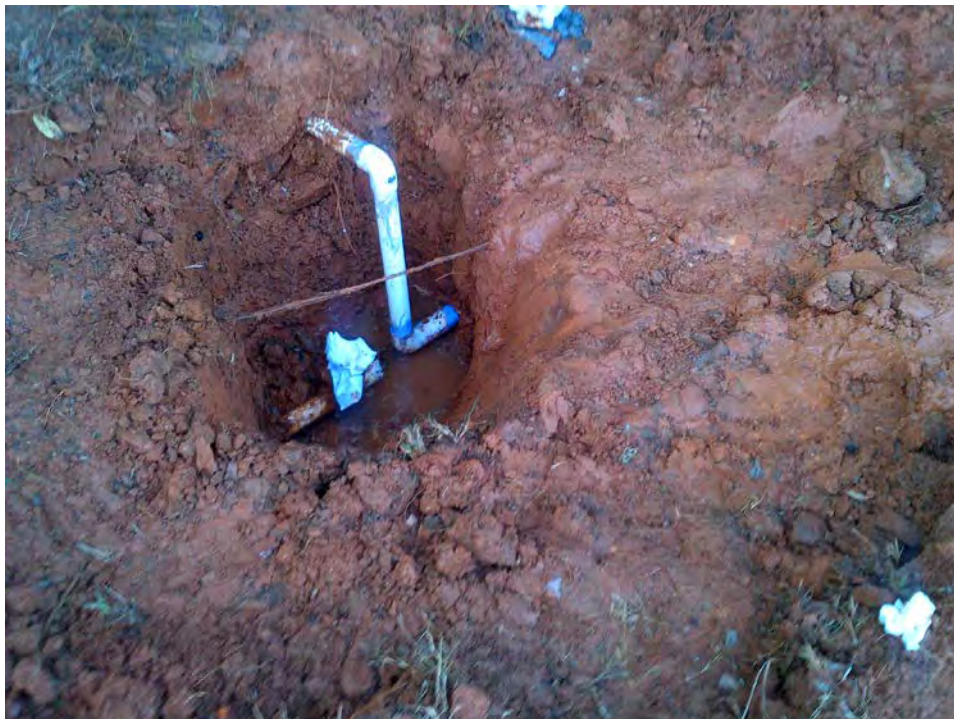
Picture 2 – Repair completed.

MIS completed the repair of the piping at approximately 6:45 pm on September 3, 2013 (see Picture 2), and the excavation was left open overnight to verify that there was no additional damage to the piping.
