Subject: The University of North Carolina at Chapel Hill (UNC-Chapel Hill) Bingham Facility (former Research Resource Facility), Notice of Violation NOV-2010-PC-0215

I am writing in response to your March 3, 2010 Notice of Violation (NOV) for the subject facility related to a failure of the distribution line from the pump house to the spray field.

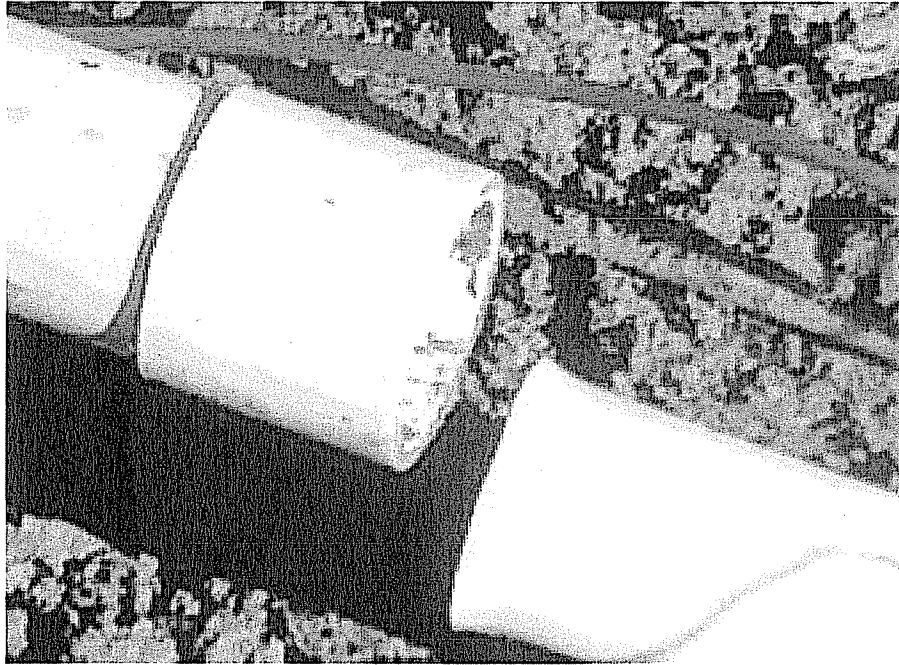
Upon further investigation of the incident, it was discovered that piping from the pump house to the spray field used two-inch PVC piping with bell-type fittings. The pipe failure occurred at one of these pipe fittings. Pictures 1 and 2 show the failed fitting.

Picture 1 – Broken bell fitting.

Repairs to the piping were completed on March 5, 2010. Picture 3 shows the open trench prior to backfilling. Picture 4 shows a new pipe fitting glued in place.

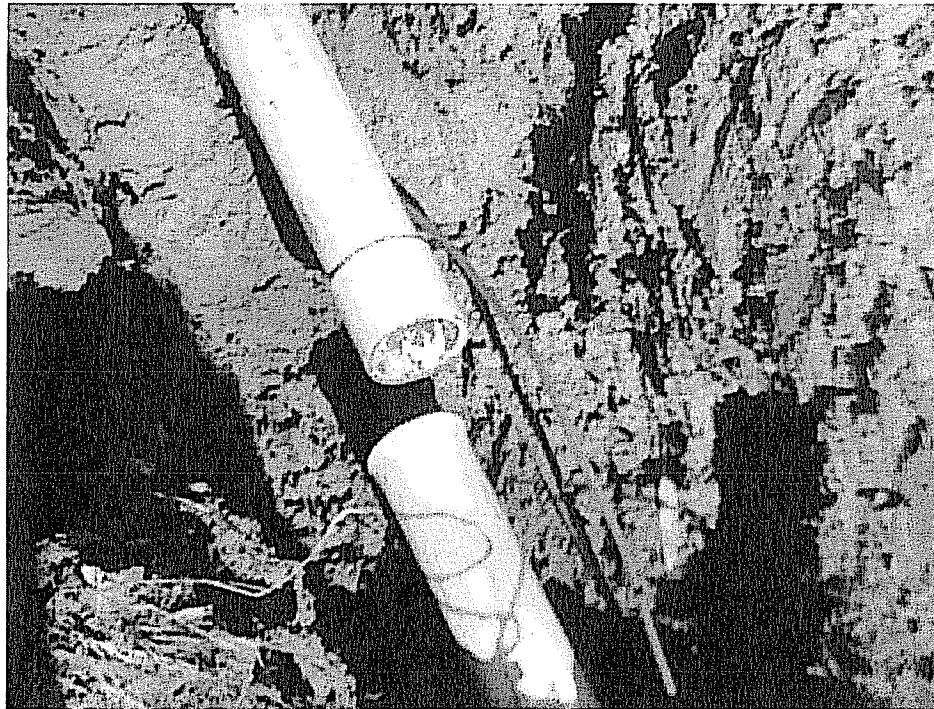
Picture 2 – Another photo of broken bell fitting.

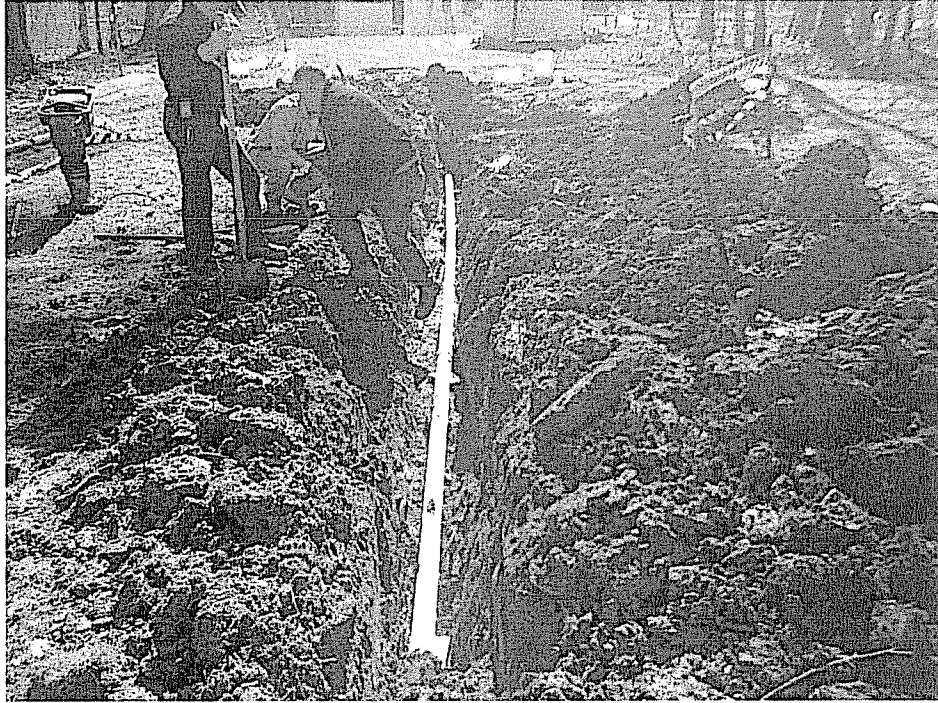
Picture 3 – Open trench and new piping prior to backfilling.

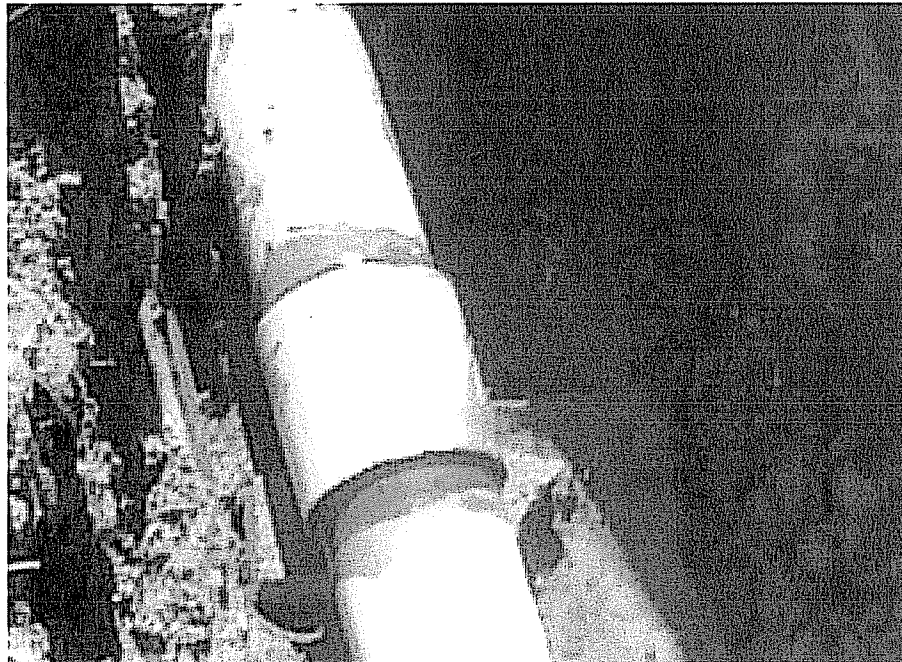
Picture 4 – Glued pipe fitting
