REMEDIAL ACTION PLAN
FOR SOIL ONLY
UNC-CH COGENERATION FACILITY
CHAPEL HILL, NORTH CAROLINA
SITE ID# NCR000010272

Geosyntec Consultants of NC, PC
2501 Blue Ridge Road, Suite 430
Raleigh, NC 27607

April 2023

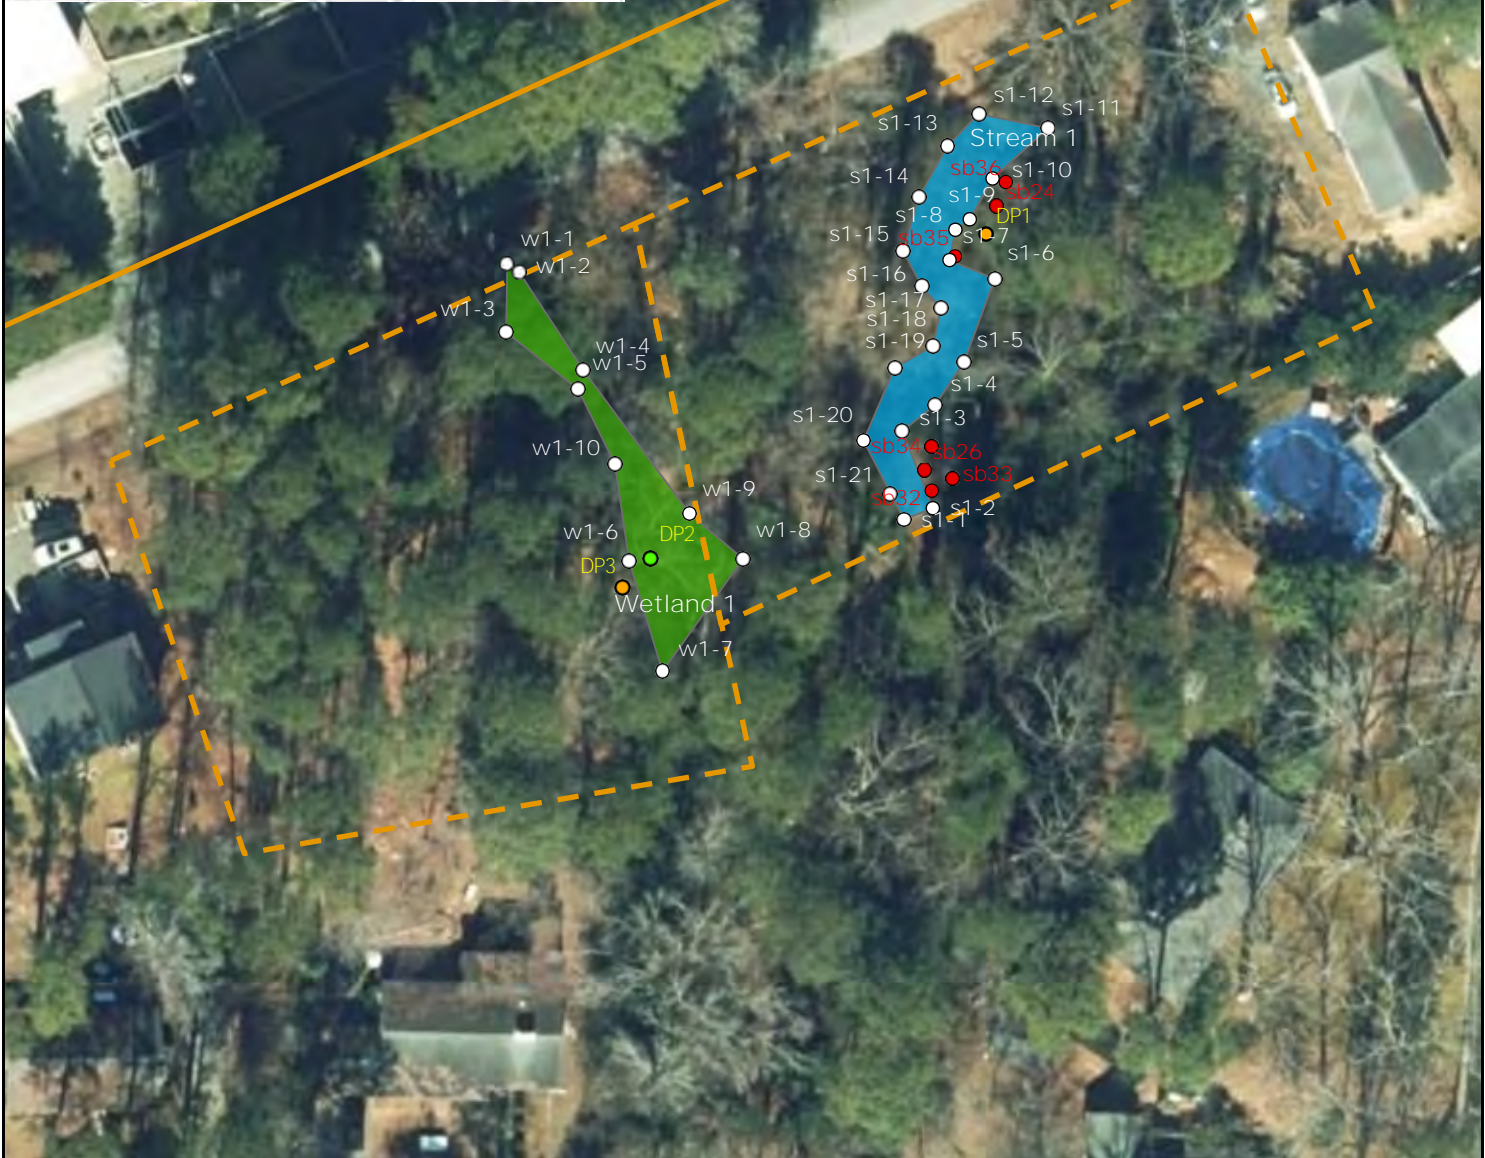
Geosyntec Consultants of NC, P.C. NC License No.: C-3500 and C-295		Figure 1
	Raleigh, North Carolina	December 2022

Geosyntec Consultants of NC, P.C. performed a wetland delineation and stream assessment to support the removal of two small, isolated pockets of impacted soil located south of McCauley Street from the Cogeneration Facility. **Figure 1** presents the surveyed area. The proposed removal actions are part of the larger soil remedy for the voluntary, Coal Combustion Byproducts (CCB) remediation at the Cogeneration Facility. Remediation of CCBs, impacted soil and groundwater is being implemented consistent with North Carolina's Department of Environmental Quality (NCDEQ) Registered Environmental Consultant (REC) program.

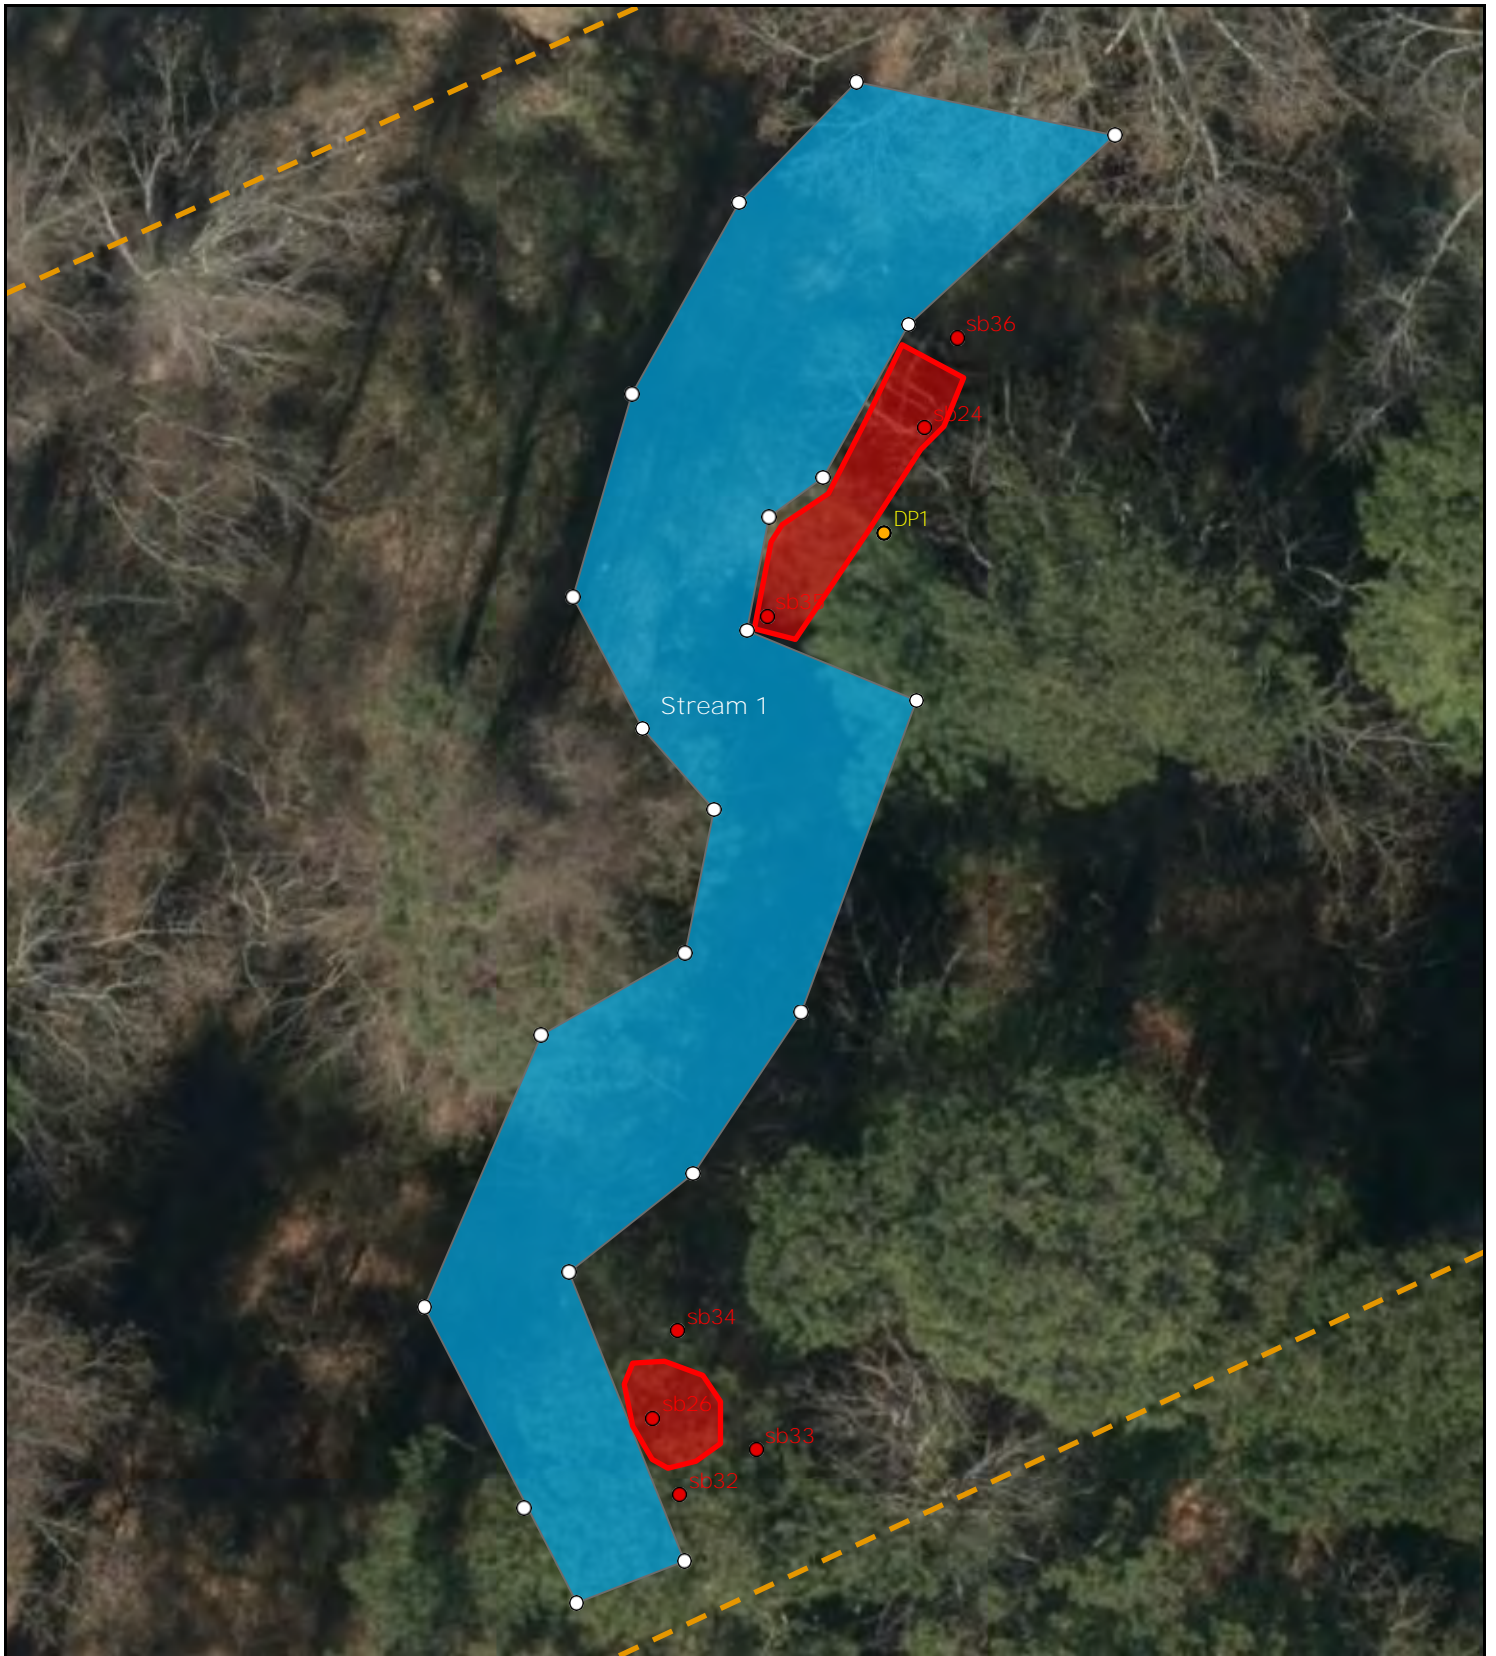
Figure
2

One wetland was delineated within the survey area; identified in **Table 1** and depicted on **Figure 2**. A photographic log is included as **Appendix A**. Geosyntec completed Wetland Determination Data Forms (**Appendix B**), where appropriate, and documented conditions observed during the assessments. Wetland acreage reported is the amount of wetland within the defined survey area.

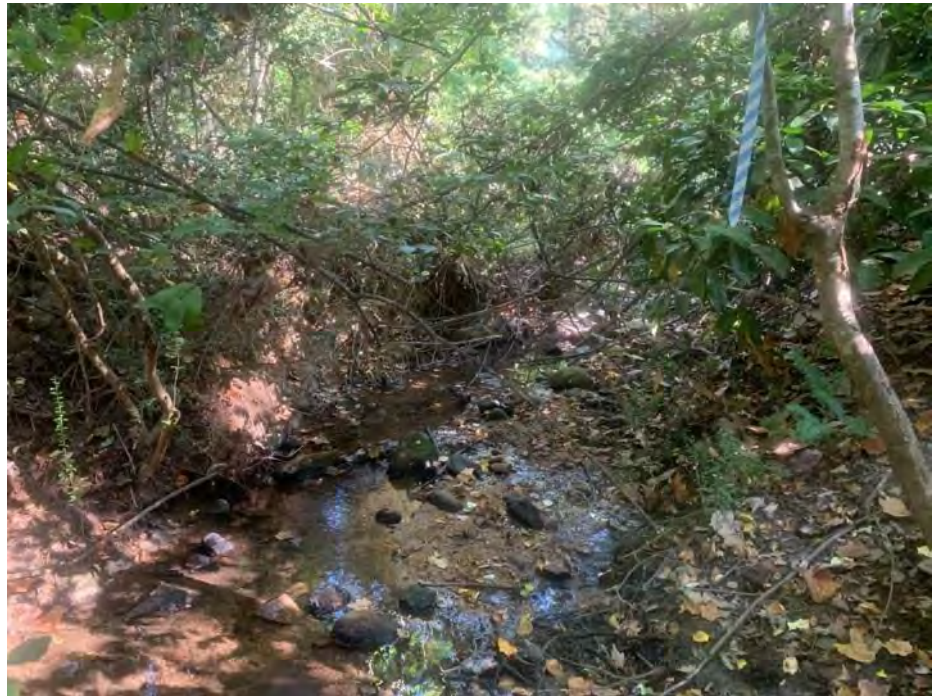
Photograph 2

Comments: Stream 1 conditions in the southern portion of the survey area. The surface water is reduced (possibly from erosion covering the stream) and there is a presence of debris and trash. The property boundary ends at the overhanging vegetation.

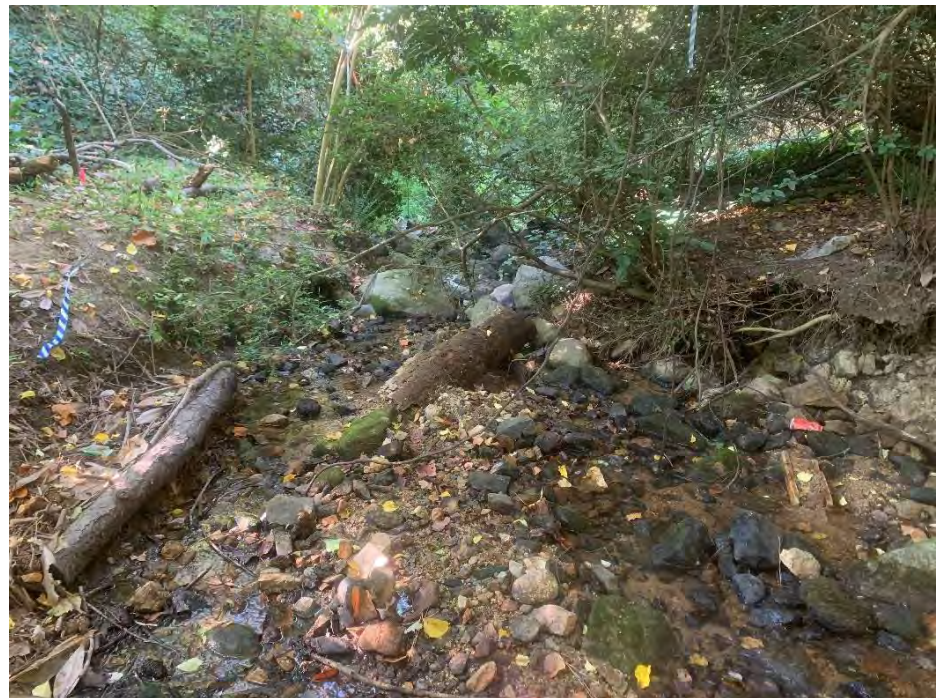
Comments: An aerial view of the upper portion of wetland 1, facing southwest towards it's ultimate confluence with stream 1 outside of the survey area.

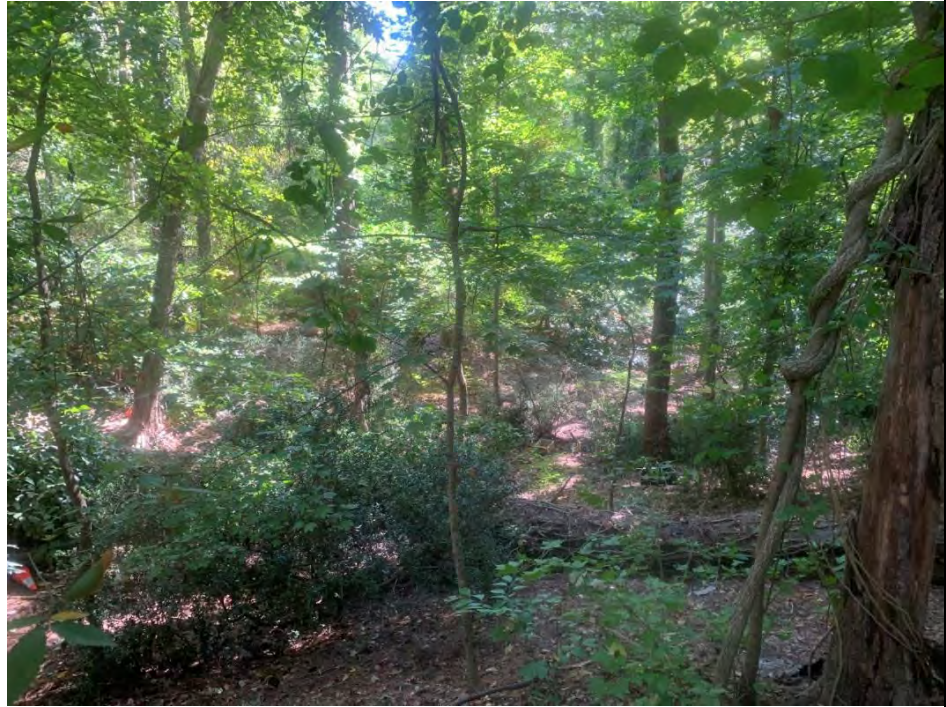
Photograph 4

Comments: Stream 1 conditions in the northern portion of the survey area, there is a large amount of debris due to proximity to McCauley St.

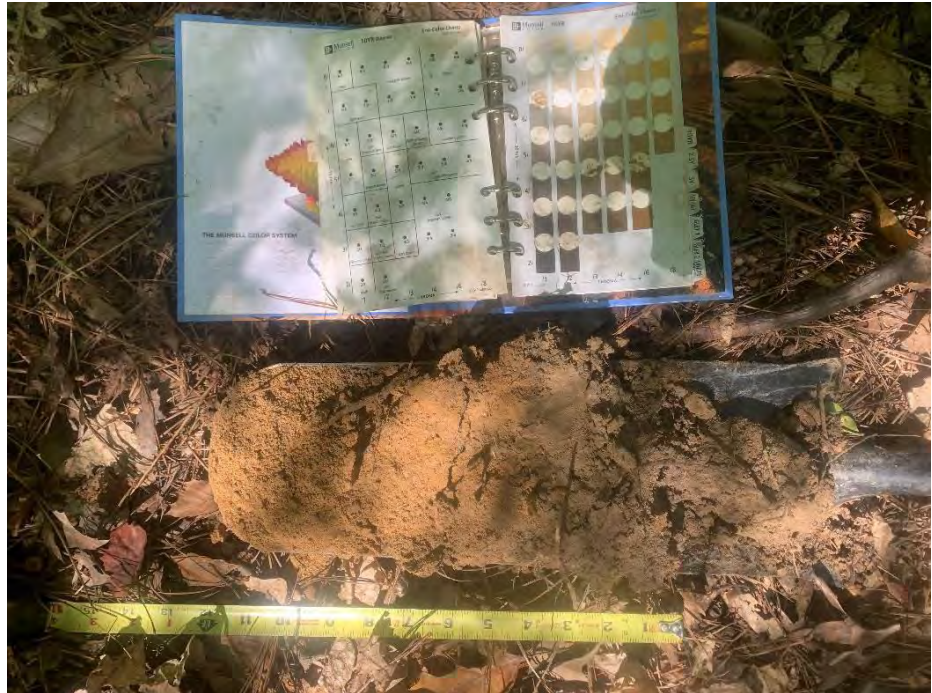
Photograph 10

Comments: Habitat conditions at data point 3, looking north along wetland 1.
